**PROJECT NEED FOR THE REHABILITATION
OF THE
ELM STREET BRIDGE
BRIDGE NO. F-09-003 (3KQ)**

**ELM STREET (ROUTE 79) OVER THE ASSONET RIVER
FREETOWN, MASSACHUSETTS**

AUGUST, 2007

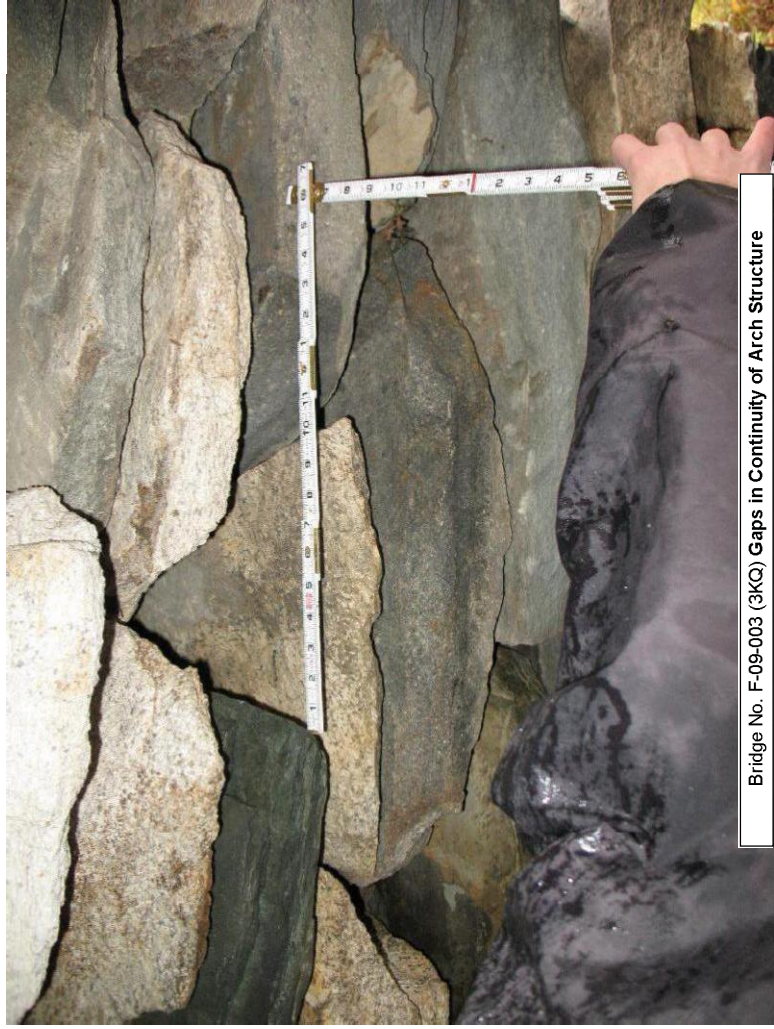
Bridge No. F-09-003 (3KQ) Gaps in Continuity of Arch Structure

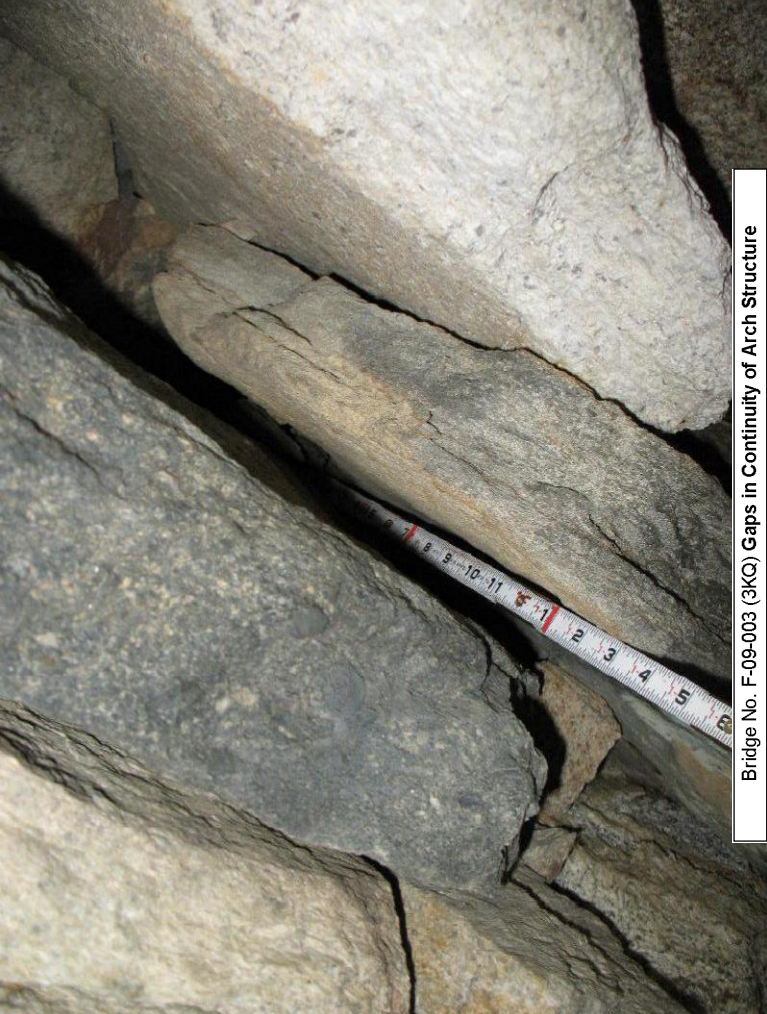
Bridge No. F-09-003 (3KQ) Gaps in Continuity of Arch Structure

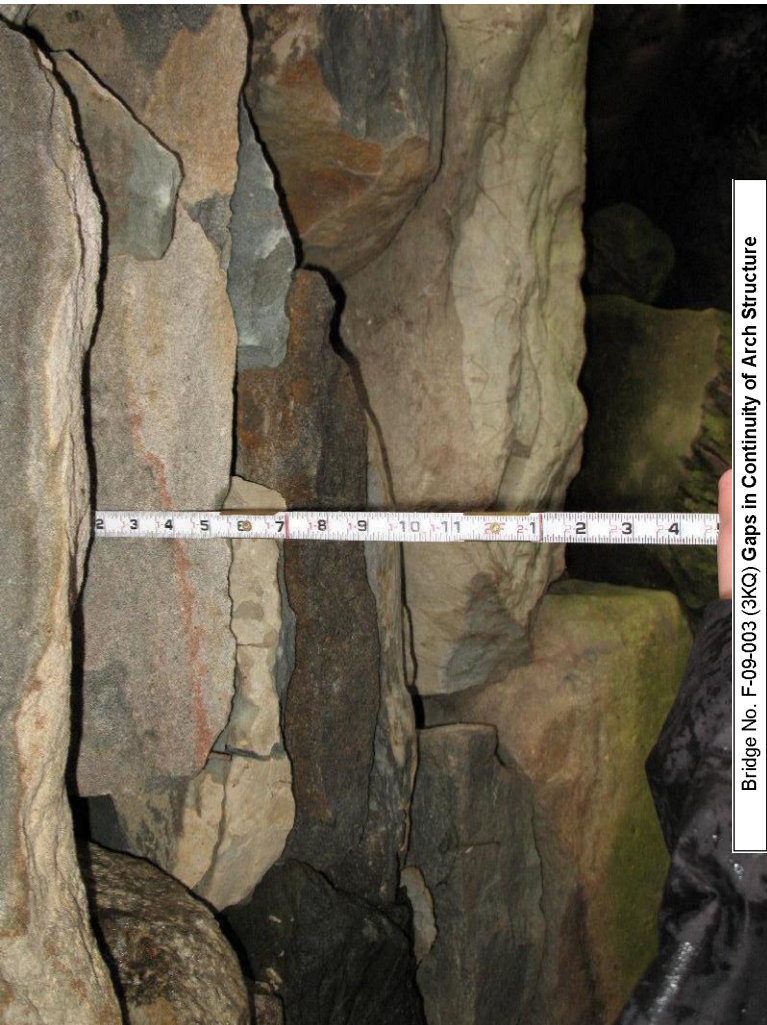
Bridge No. F-09-003 (3KQ) Gaps in Continuity of Arch Structure

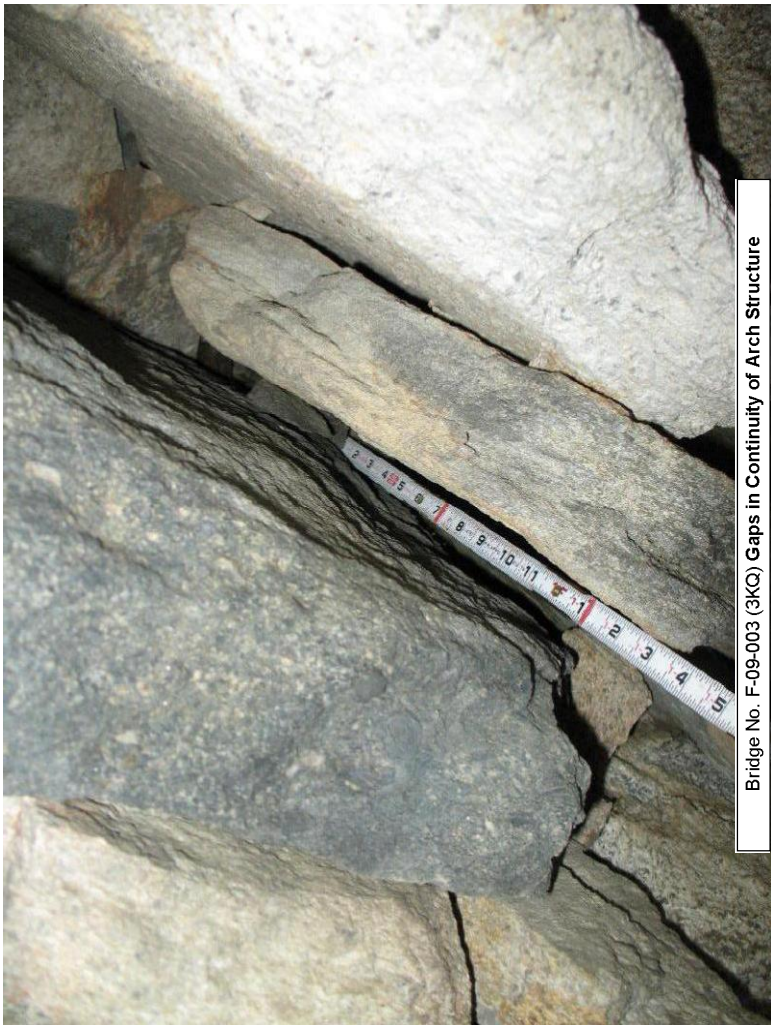
Bridge No. F-09-003 (3KQ) Gaps in Continuity of Arch Structure

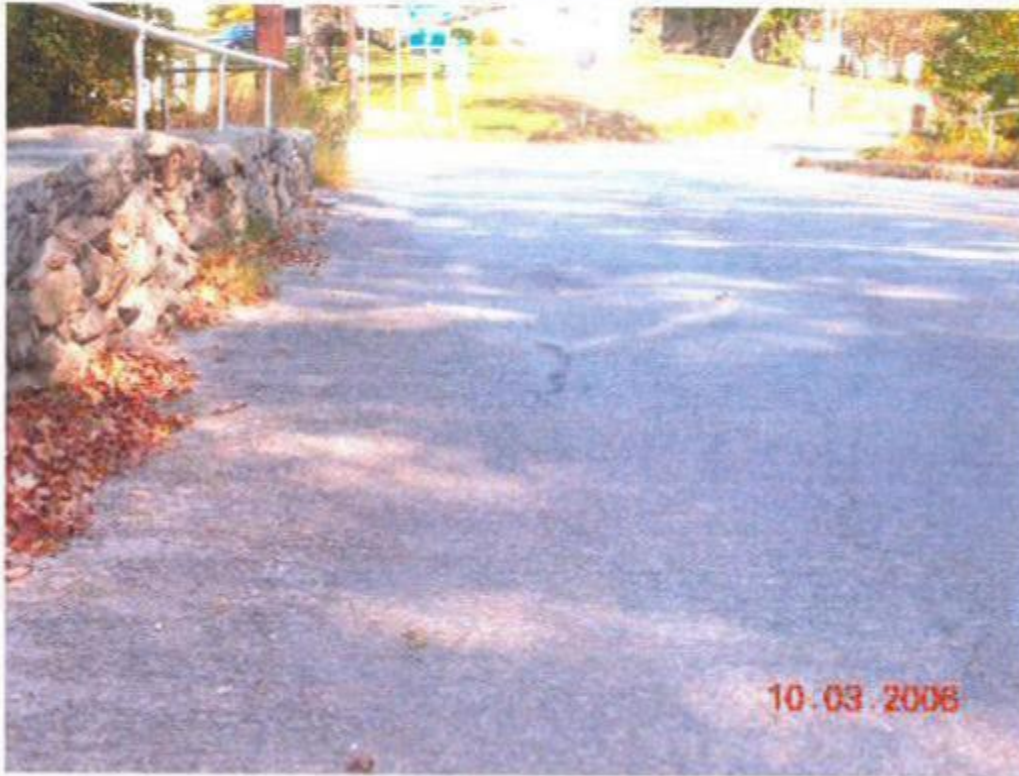
Random cracks and uneven/rutted areas, especially at the north. There is a 5ft by 3ft patched area that is also settling at the north adjacent to the masonry wall. There is heavy truck traffic causing vibration to the structure from the impact loading. S/A Deficiency. See photo 1.

The repaired area on the north side of the wearing surface over the sag in the center barrel continues to settle. S/A Deficiency

Photo 1: Cracks, ruts, settling, and patched area, north side

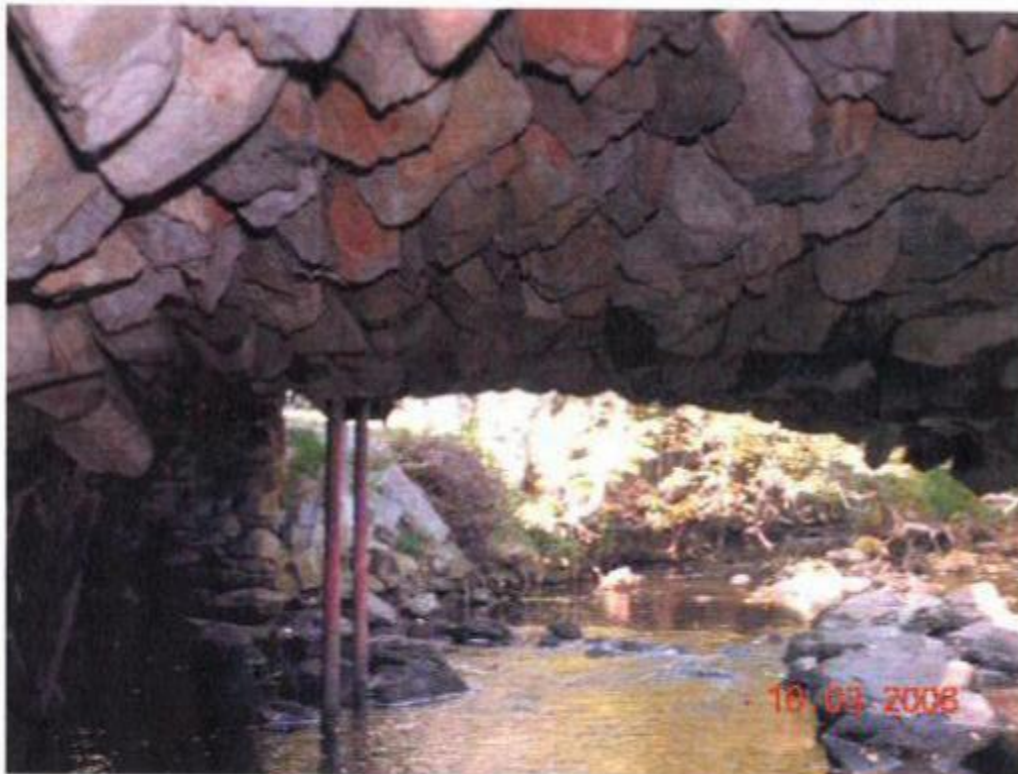
Photo 2: West arch, north end

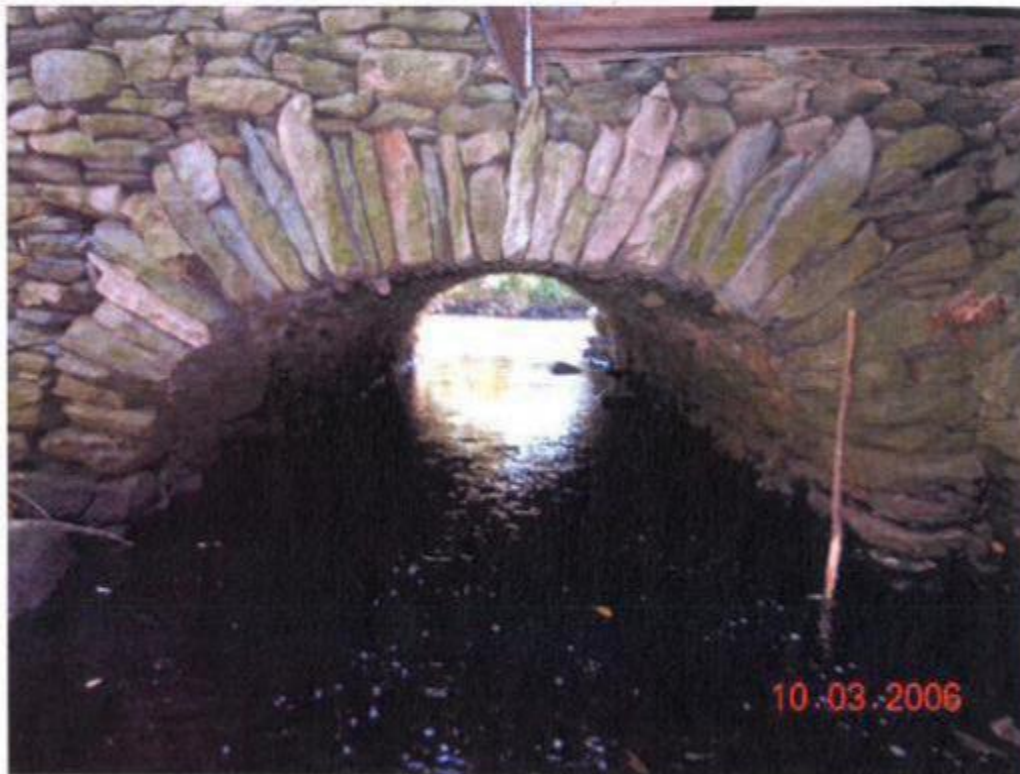
Photo 3: West arch, north end

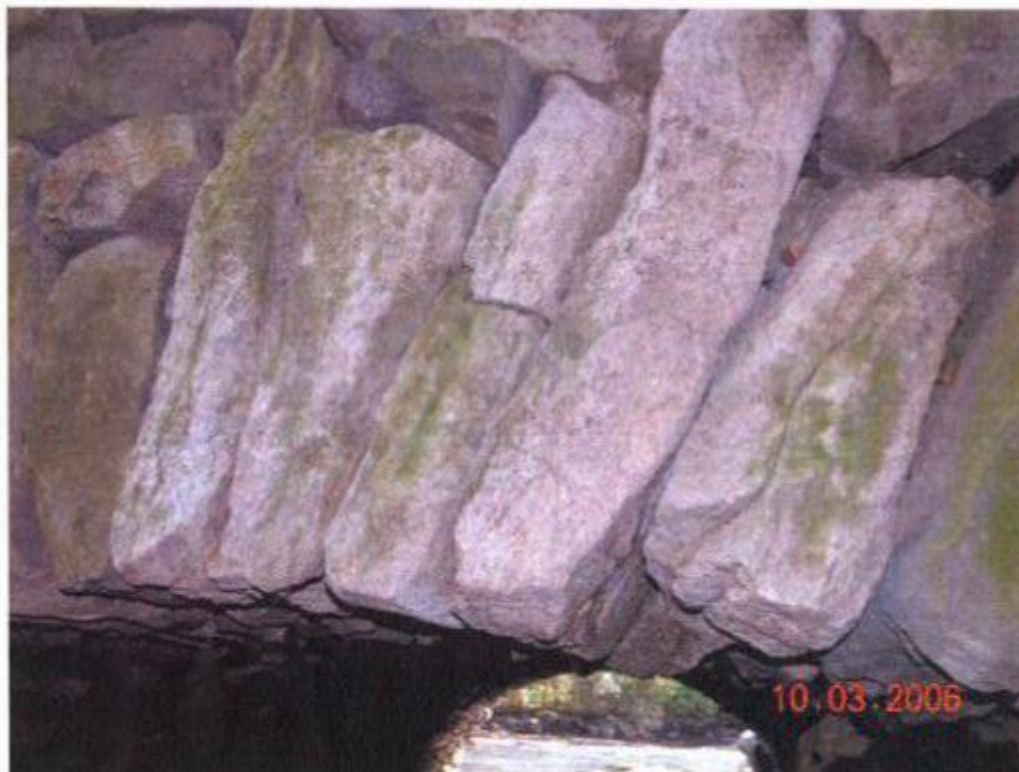
Photo 4: West arch, north arch ring: Cracks in two stones appear unchanged

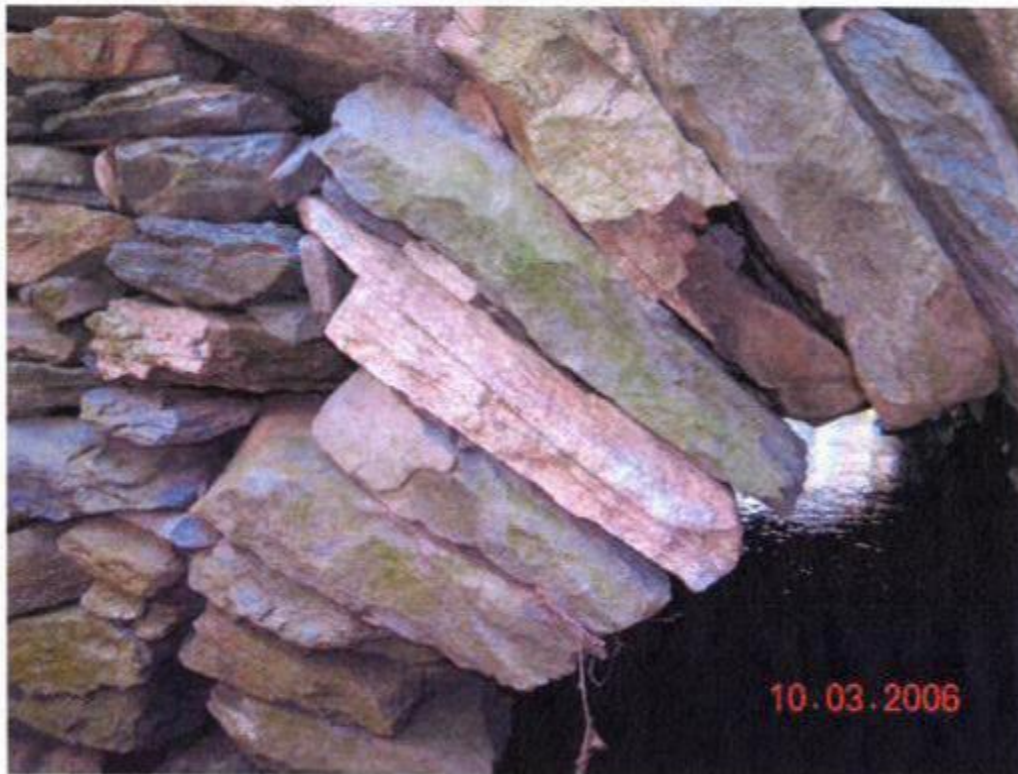
Photo 5: West arch, north arch ring: Cracked and broken stones appear unchanged

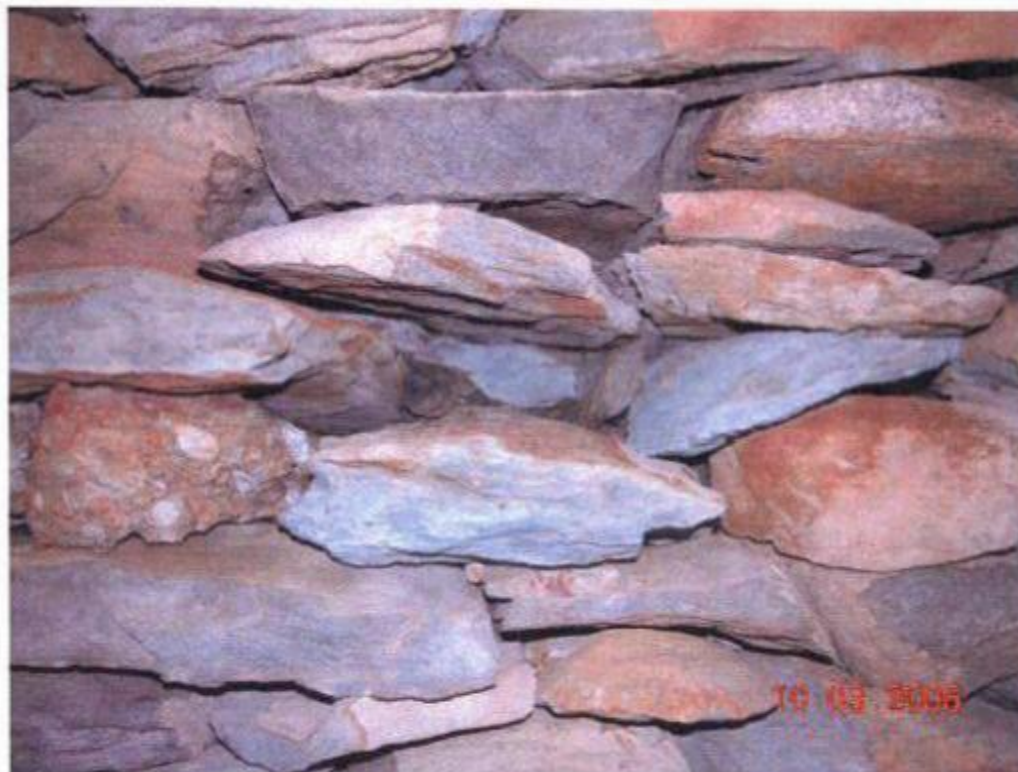
Photo 6: West arch at keystone area, 10-11ft from north at beginning of sag: Recent void 1ft L x 6in H x 16in D

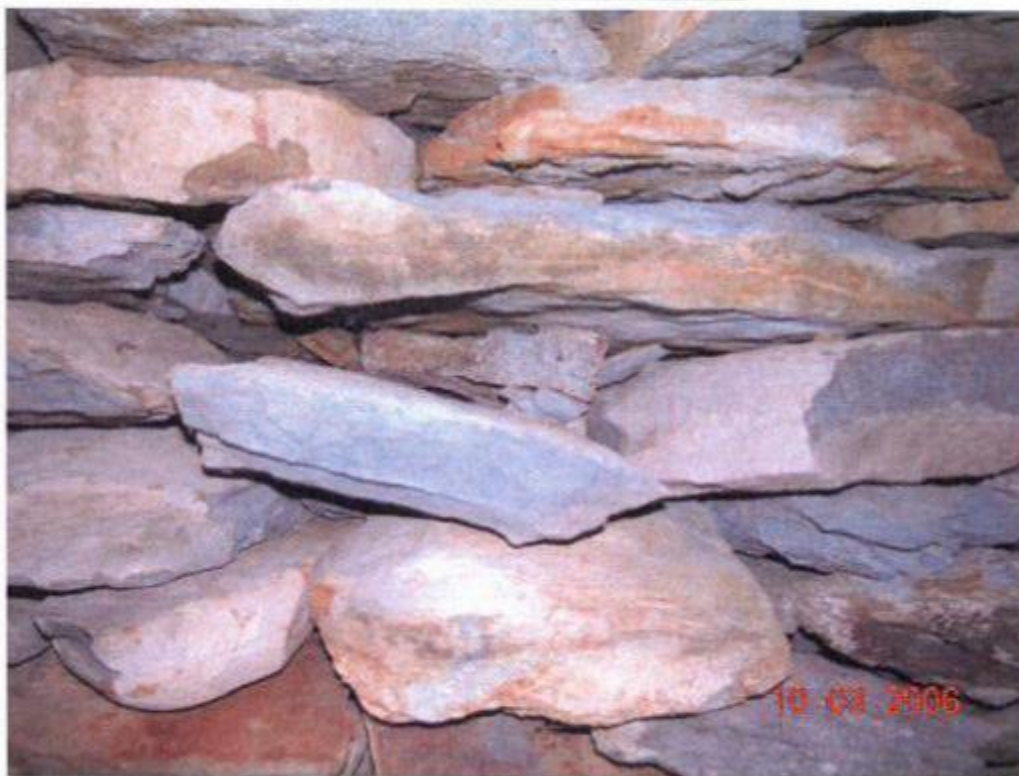
Photo 7: West arch at keystone area, 16-17ft from north: Recent void up to 1.5ft L x 6in W x 1.5ft D

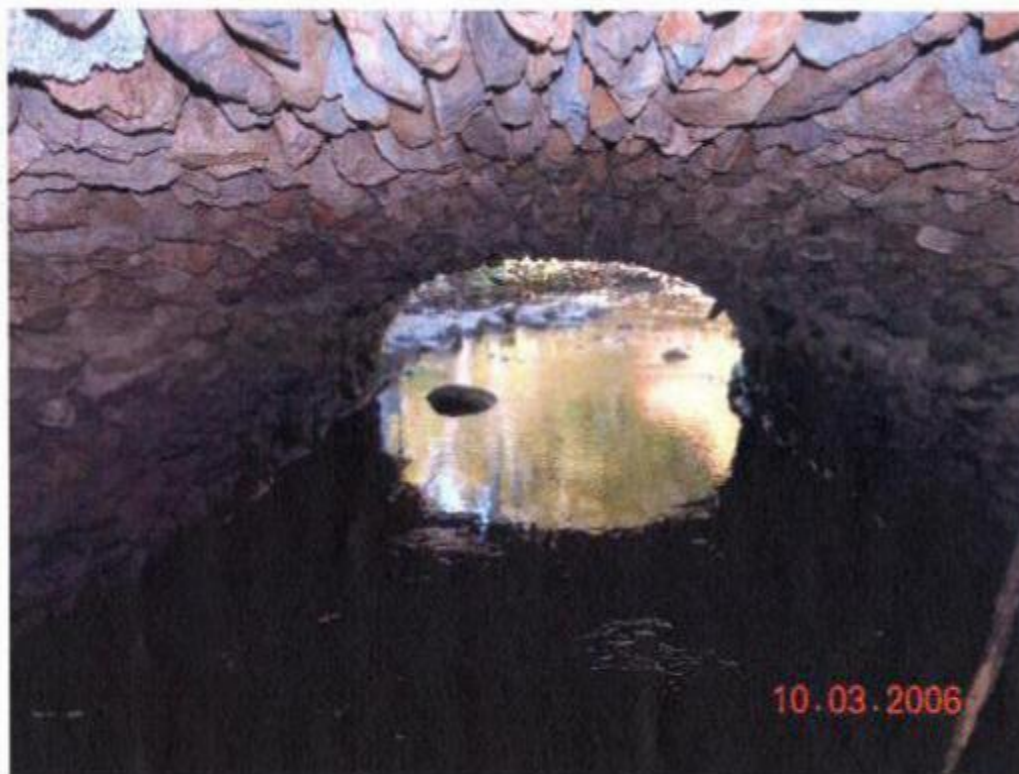
Photo 8: Middle arch looking north

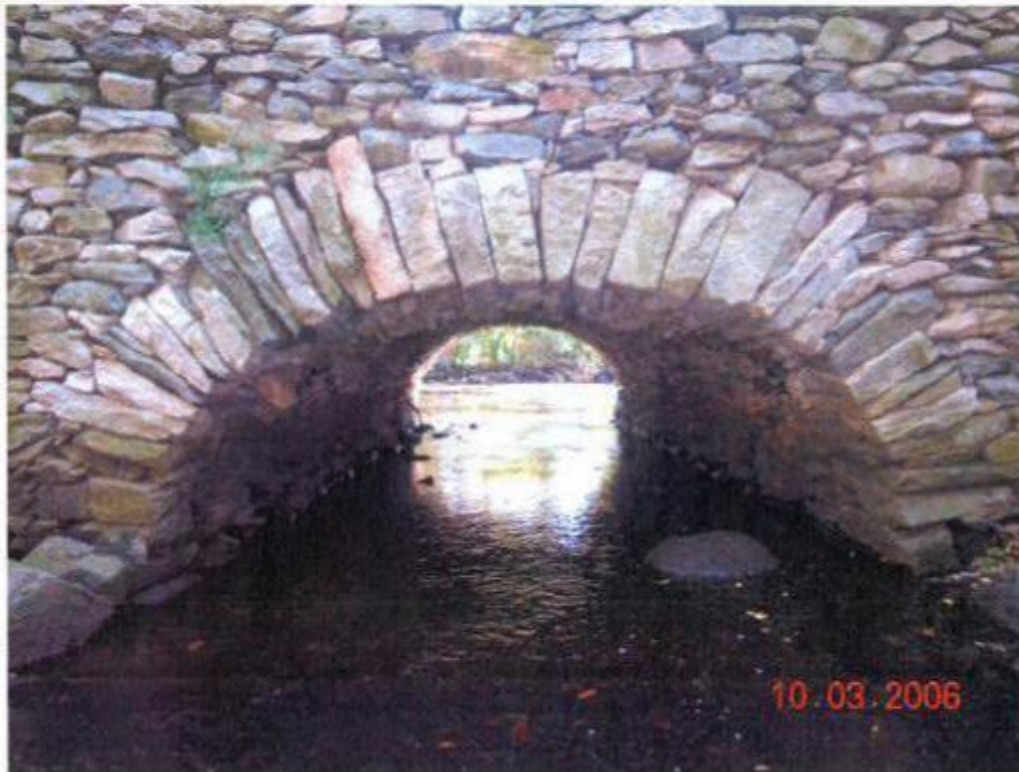
Photo 9: Middle arch looking south

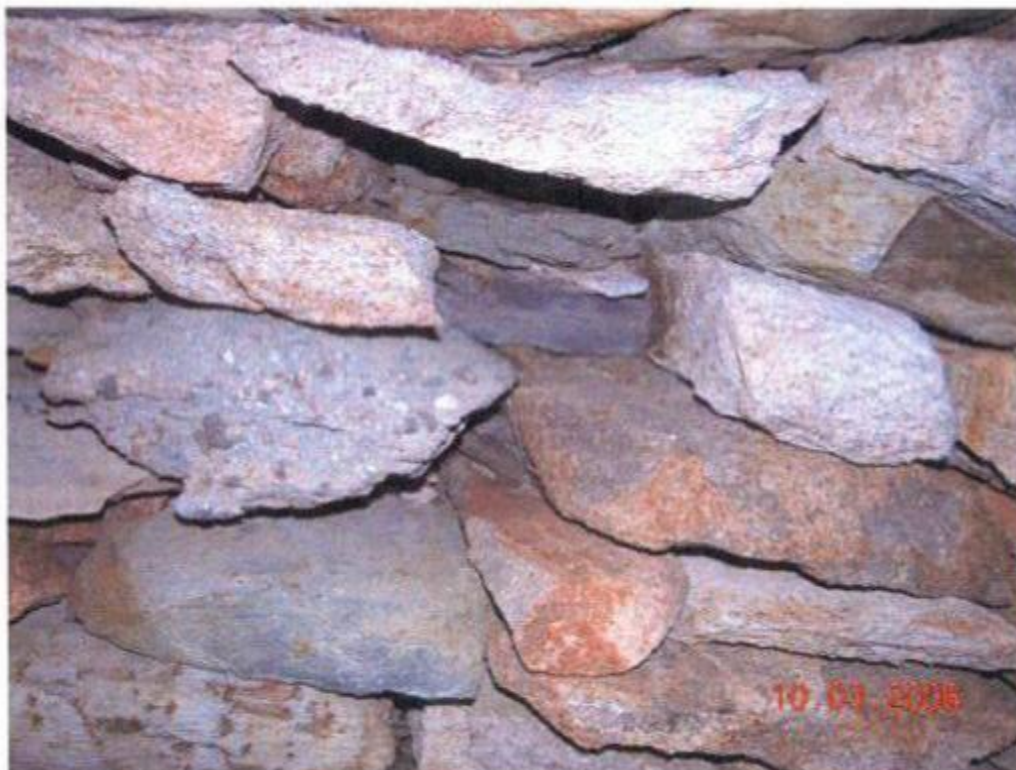
Photo 10: Middle arch at middle near top: Void up to 1.5ft x 1.5ft x 16in D

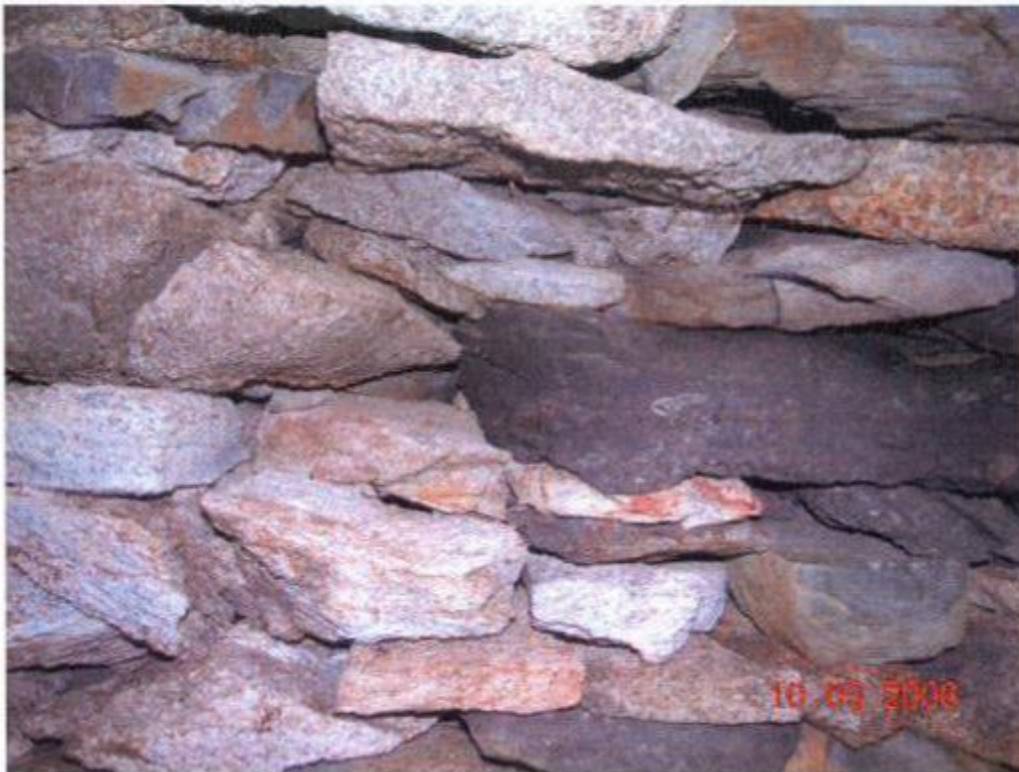
Photo 11: Middle arch, 4ft up east side, 11-12ft from south: Void 2ft L x 14in W x 1.5ft D

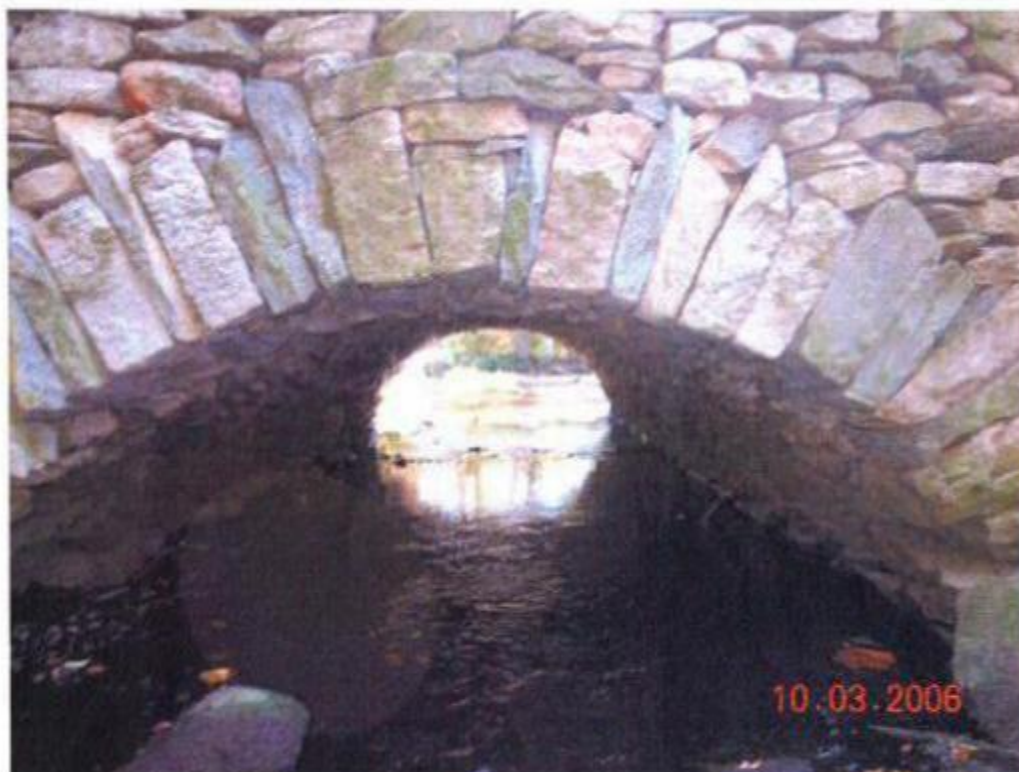
Photo 12: East arch at north

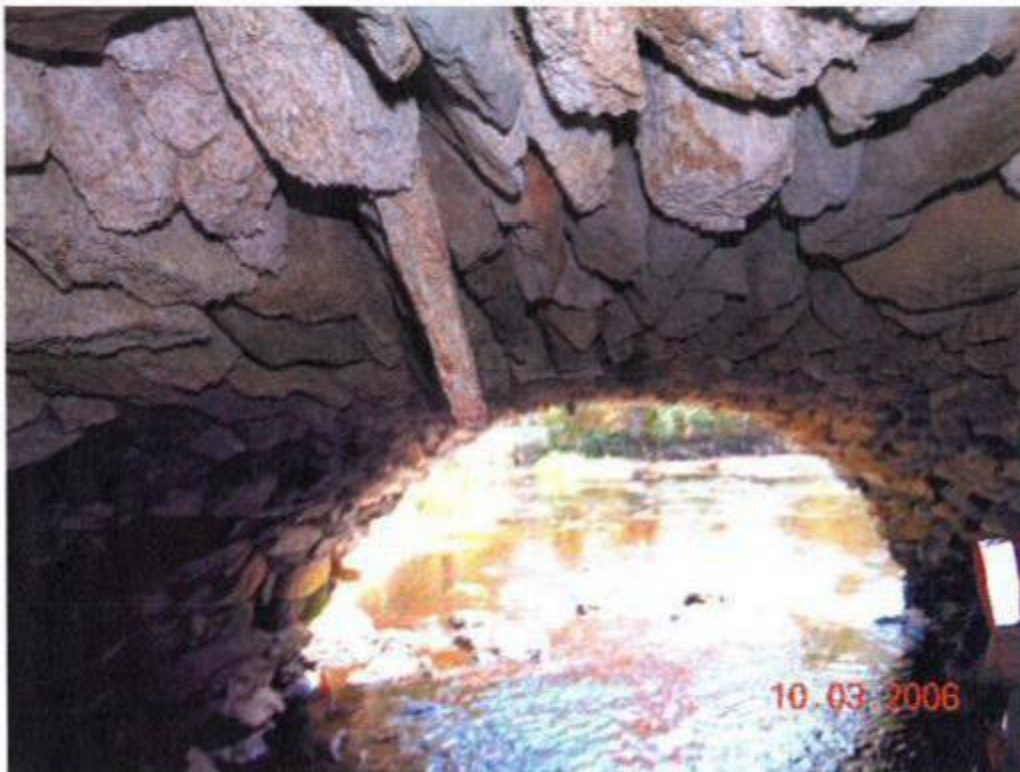
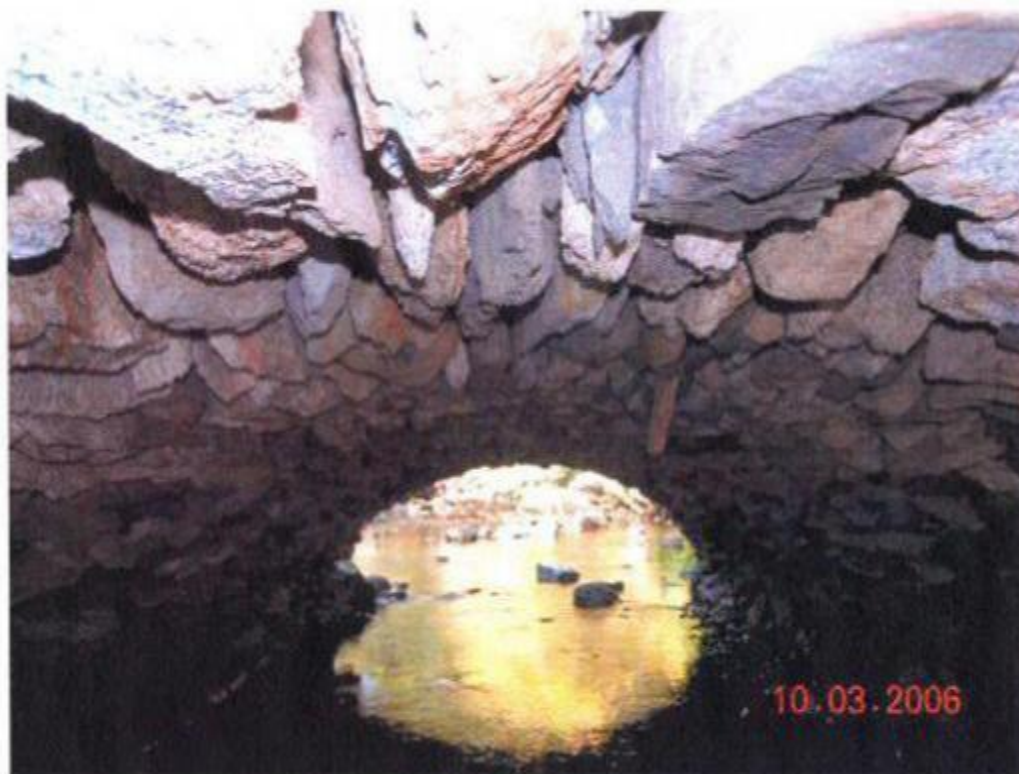
Some of the hanging stones are loose and the one in Photos 13 & 14 also fell out during the inspection.

Photo 13: East arch looking south: Loose hanging stone which later fell out

Photo 14: East arch looking north

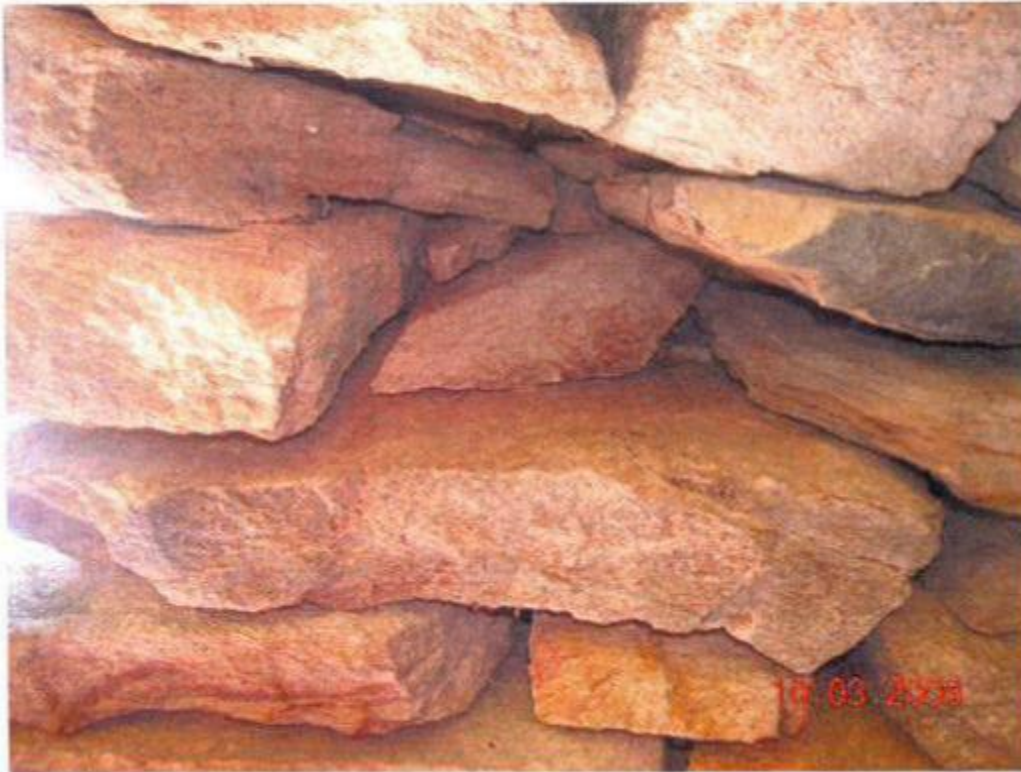
Photo 15: East arch at southwest: Void 20in L x 1ft W x 16in D

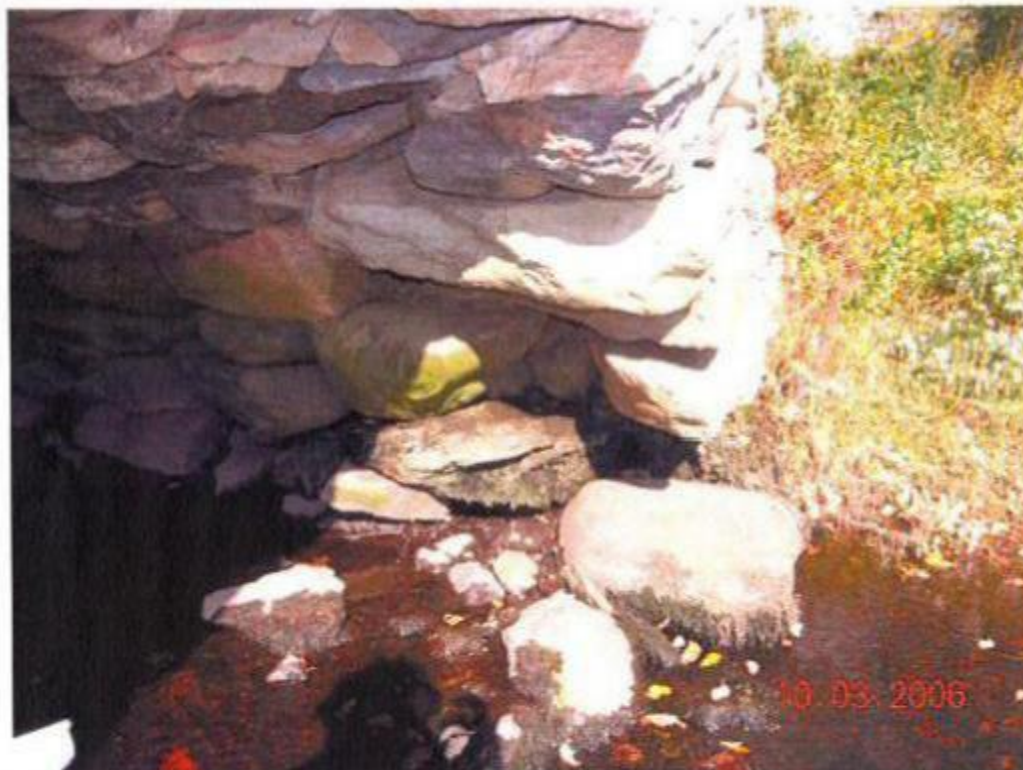
There are no discernible spring lines. The breastwall areas have many cracked stones and some voids. There is no change to a previously reported void at the bottom of the southeast breastwall/arch ring/wingwall 3in long by 22in high by 18in deep. See Photos 16 & 17.

Photo 16: East arch at SE: Void at bottom of arch ring/breastwall/wingwall interface 32in L x 22in H x 18in D

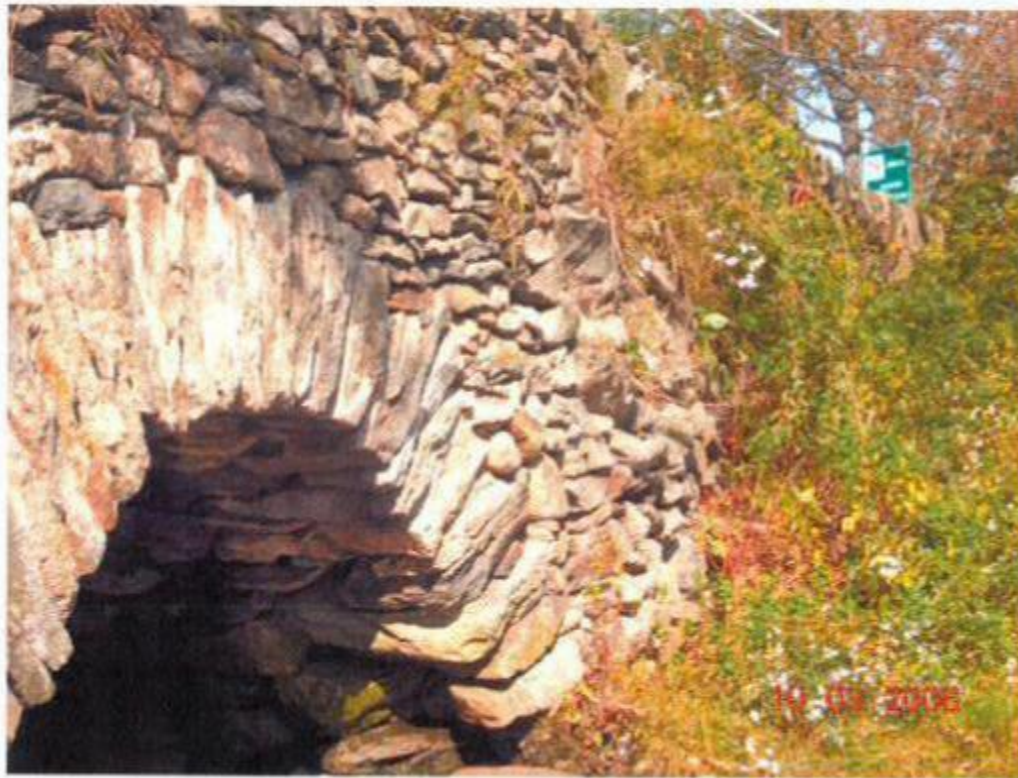
Minor voids and cracked stone typical for this type of structure. See Item 60.1.d for a void at the SE corner. **The SE wingwall has a large bulge in the middle. See Photo 17. S/P Deficiency**

Photo 17: Bulge in SE wingwall
